Holbækmotorvejen Roskilde, DK

Sheet pile wall anchoring with temporary strand anchors in order to secure a roadway at a motorway and railway bridge

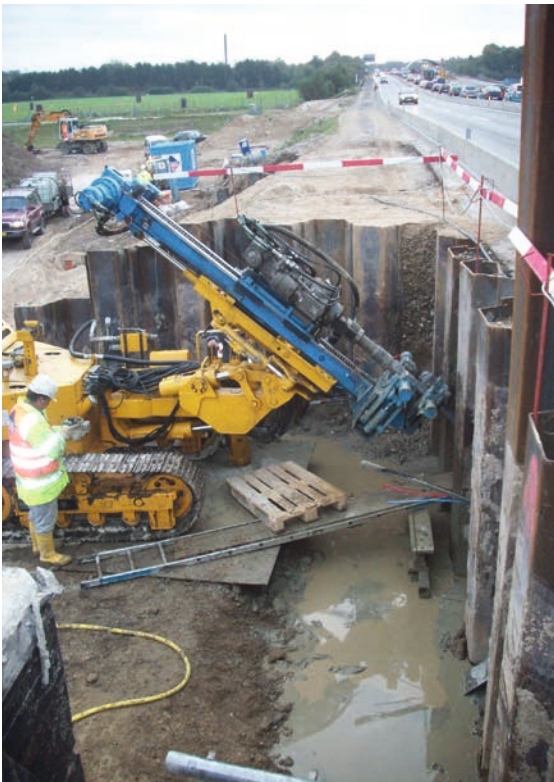
Image 1

On the southwest side of the bridge crossing Ringstedvej we anchored a sheet pile wall with 10 temporary strand anchors with 3 strands each in order to stabilise the elevated roadway for the duration of the construction works (see Image 2). The water supply of our drill unit was established by means of a tank truck. Due to the relatively enclosed position of the last drill point near the counterfort, we moved this anchor in agreement with our client in a way such that a perpendicular joint to the intended waling could be established with ease. A few weeks later, we were supposed to anchor the northeast and the southwest side of the neighboring motorway bridge across the railway line with 3 pcs. temporary strand anchors. Absorbing and transmitting the active earth and traffic loads acting upon the sheet pile walls into lower subsoil layers our grout anchors thereby stabilise the roadway and protect it from settling. Due to an even tighter working niche than on the previous mission, we chose a compact mini drill rig to execute this job (see Image 1).
